UNITED STATES DEPARTMENT OF AGRICULTURE, FOREST SERVICE

Starting Heavy Equipment During Cold Weather
By Wilfred S. Davis, Project Superintendent, Camp F-14,
Lightning Creek - Region 2

S H O P P R A C T I C E

T R A C T O R S

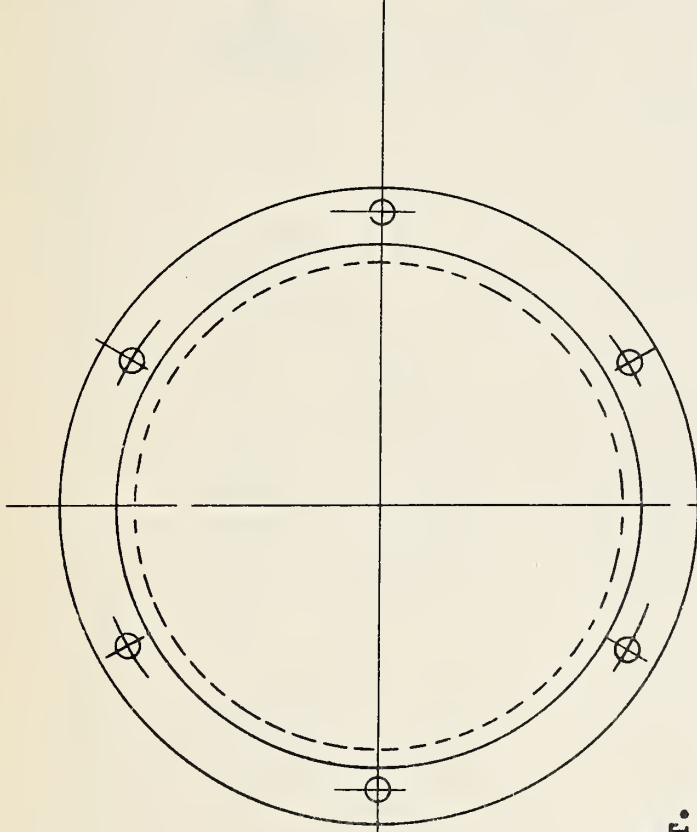
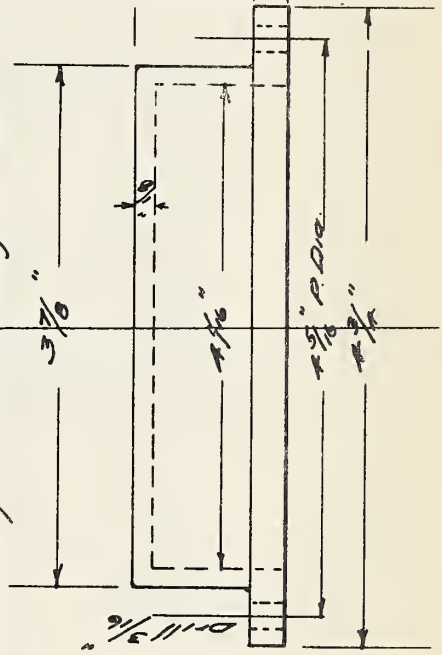
OIL SEAL FOR CAT. STEERING CLUTCH

The Caterpillar "50" has given considerable trouble in the steering clutches, due to the oil or grease working from the final drive compartment into the clutch compartment along the pinion gear shafts.

This trouble has been quite easily remedied by the use of the grease retainer shown at the RIGHT.

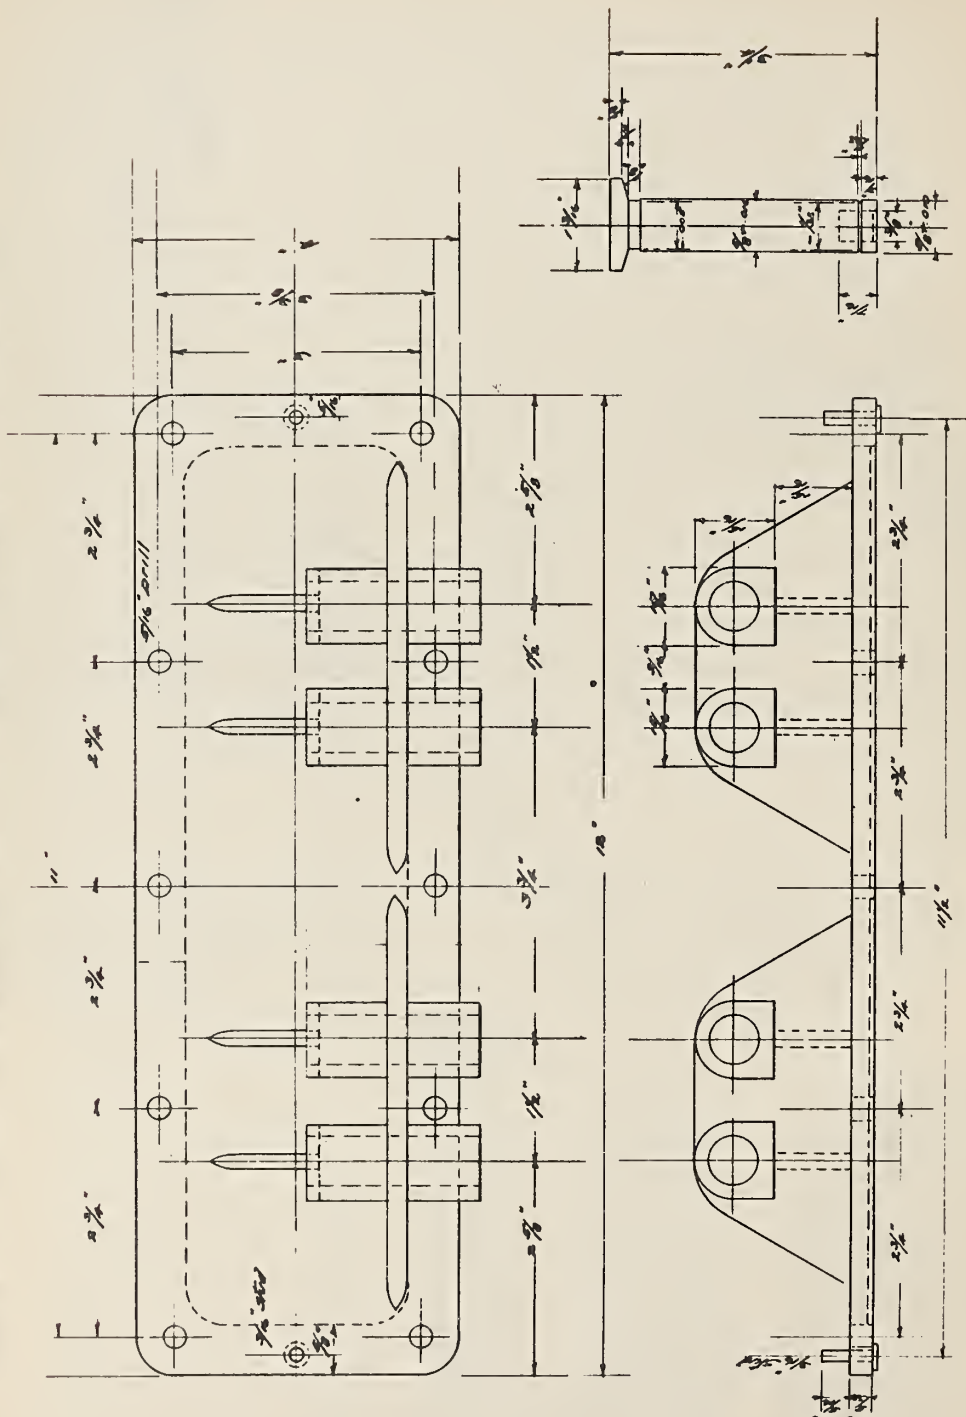
TAPPET ASSEMBLY-SS CAT.

Worn valve tappet assemblies of the Wisconsin motor are salvaged by boring and reaming the tappet guides and installing oversized tappets as shown below.

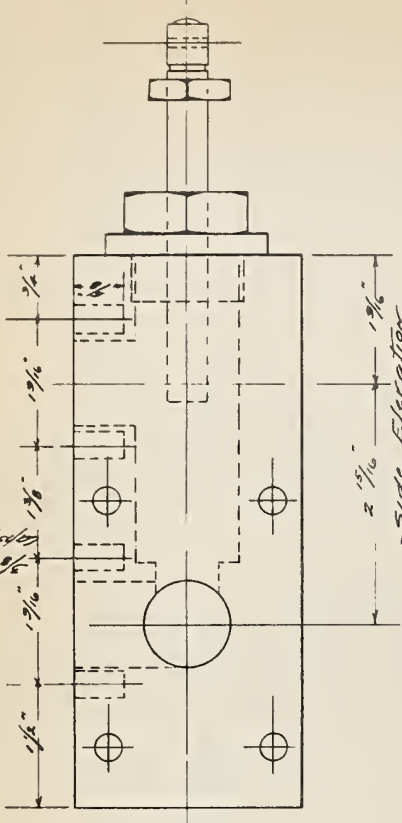
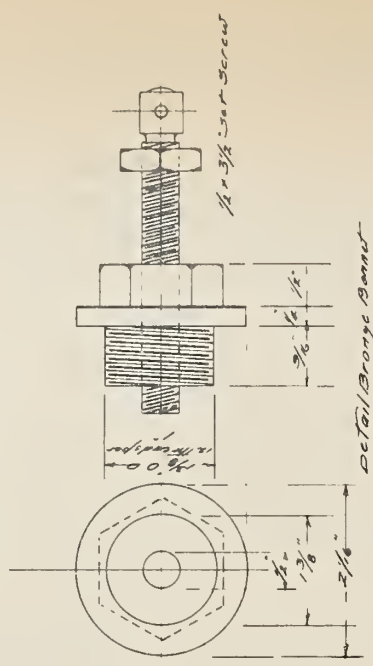
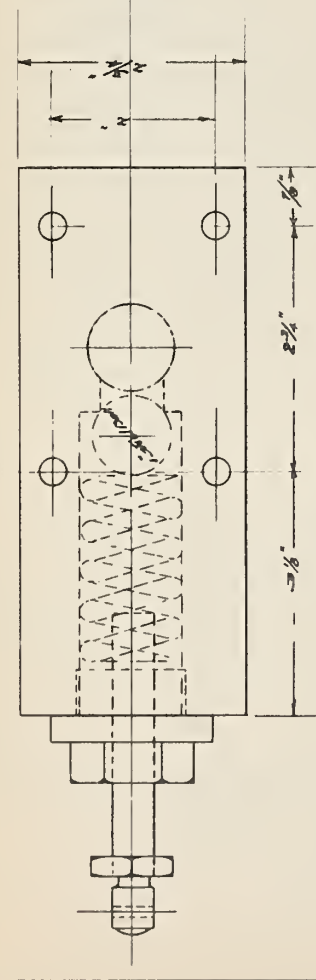
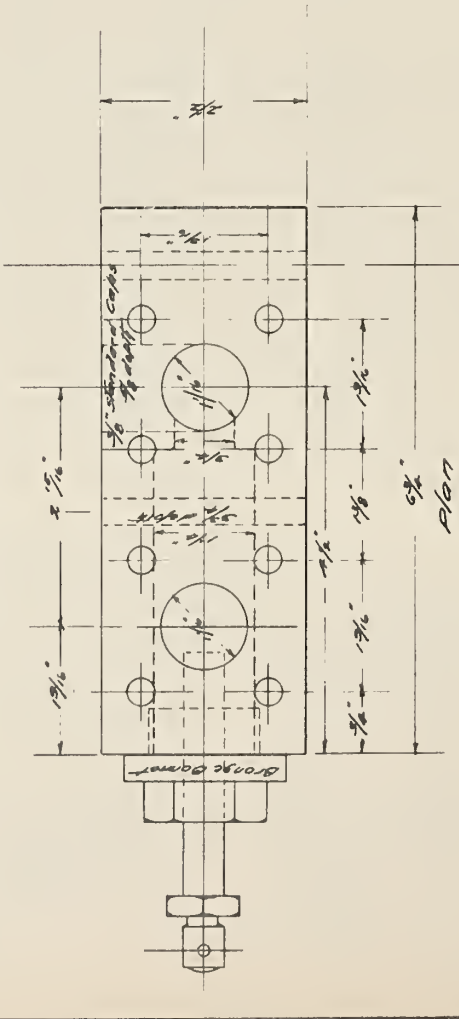
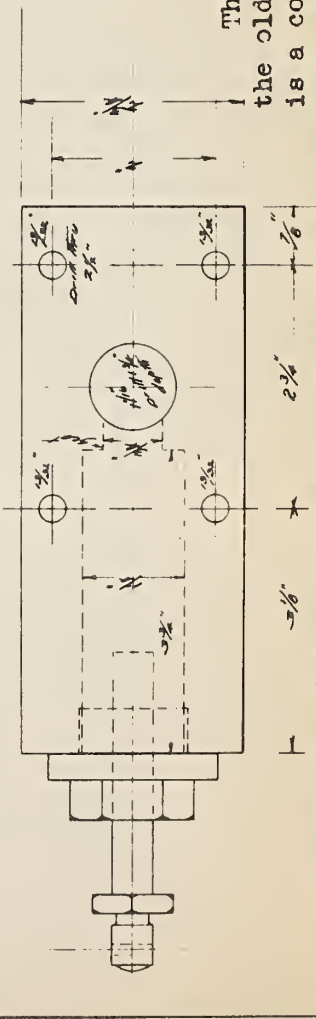
Redesigned Assembly Lower Bearing + Shaft. Part 3 + 1129. + 40285-

The lower track wheel bearing on the Cletrac is not of the anti-friction type, and since the wearing surfaces are steel to cast-iron, and also, with the additional weight of the trailmaker, the more or less positive method of lubrication has caused a considerable amount of wear and repair on this bearing. The standard Cletrac bearing is made in two halves and is sometimes rather difficult to seal against oil leakage.

Since a large percentage of discarded bearings and shafts were serviceable except for worn bearing surfaces, considerable effort was expended on the salvage of these parts. This was finally accomplished in the following manner:

The two halves of the worn bearing were assembled and bored to 2-1/2 inches internal diameter. A bronze bushing of high tin content was then turned to fit the bearing, which was bored to 1-31/32 inches or 1/32 smaller than the standard Cletrac shaft, plus .010 for clearance. No dowels are used, since the distance between the bolt holes in the bearing is less than the outside diameter of the bushing. It is necessary to run a drill through the stud holes of the assembly - by so doing, a groove is cut in the bushing. (This prevents the movement of the bushing when the bearing is installed on the track frame studs.) Since the oil seal contacts a single bronze surface instead of the broken surface of the two halves, no difficulty has been experienced at this point. The shafts that are serviceable except for worn bearing surfaces are then ground between centers to 1/32 of an inch undersize, and installed in the bearing assembly.

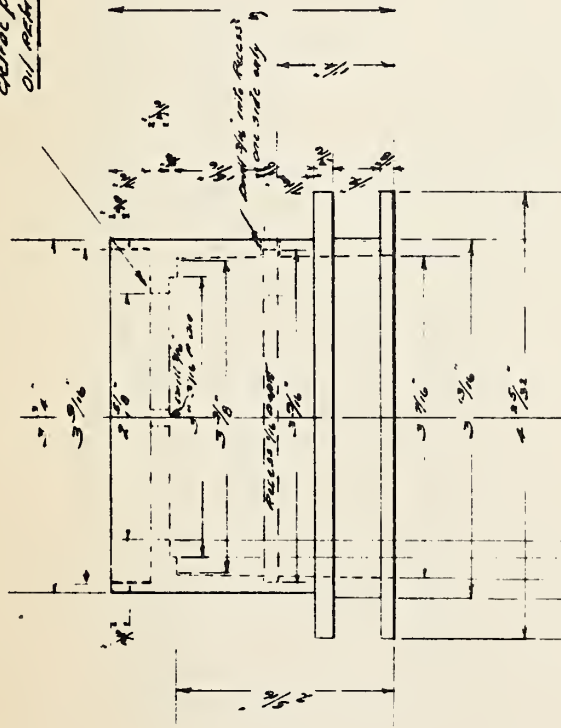
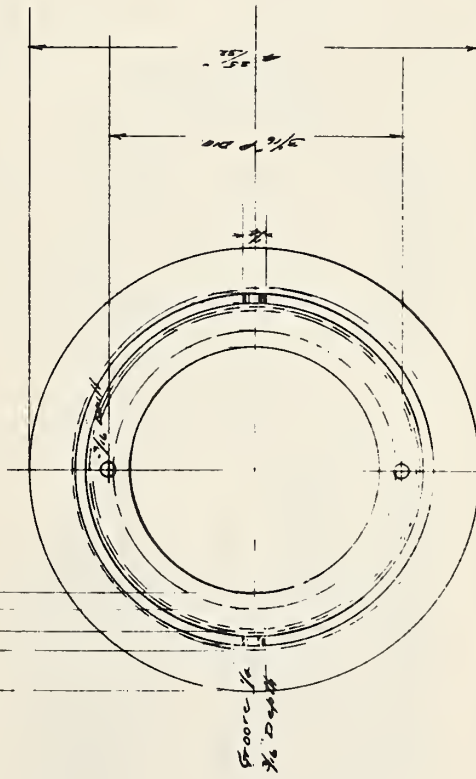
Clutch Retractor Collar finished
from Mall Steel casting

The retractor collar on the Cletrac has given some trouble, principally because of lack of lubrication.

When trouble occurred in the clutch, difficulty was experienced in shifting gears and the corners of the teeth of the gears were prematurely worn away. The above collar was adopted.

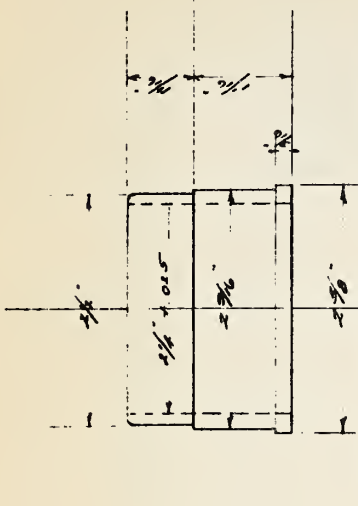
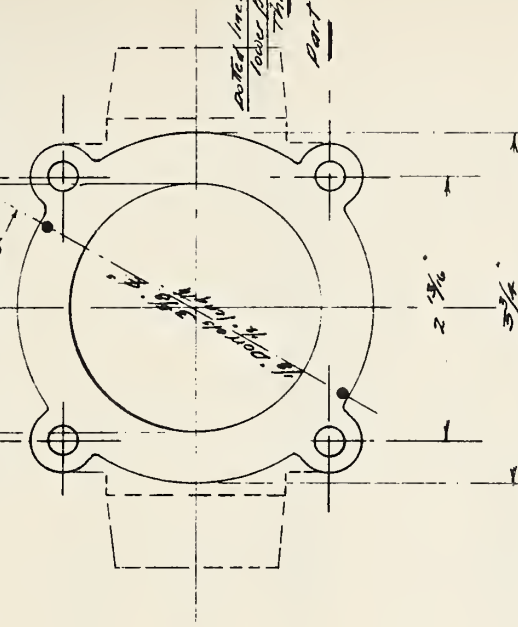
Sleeve for Thru-bolt Bearing Cap Cover

Cap Cover bolts to Cap. Drill for 1/8 Dowels
which centered as per detail. Sleeve to
run free with assembly Part 42220

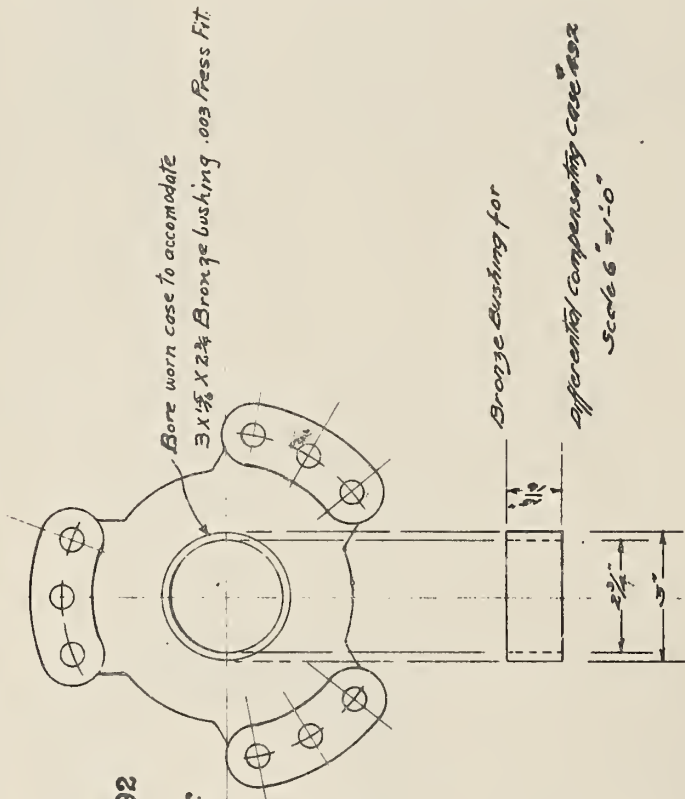
COMPENSATING CASE BUSHING FOR CLETRAC "55"

The bearing surfaces from the differential compensating case Part #492 to the drive shaft, are "steel to steel". The wear at this point is sometimes considerable.

The compensating case spider is bored out, and a bronze bushing pressed in place. The cost is about \$2.50.

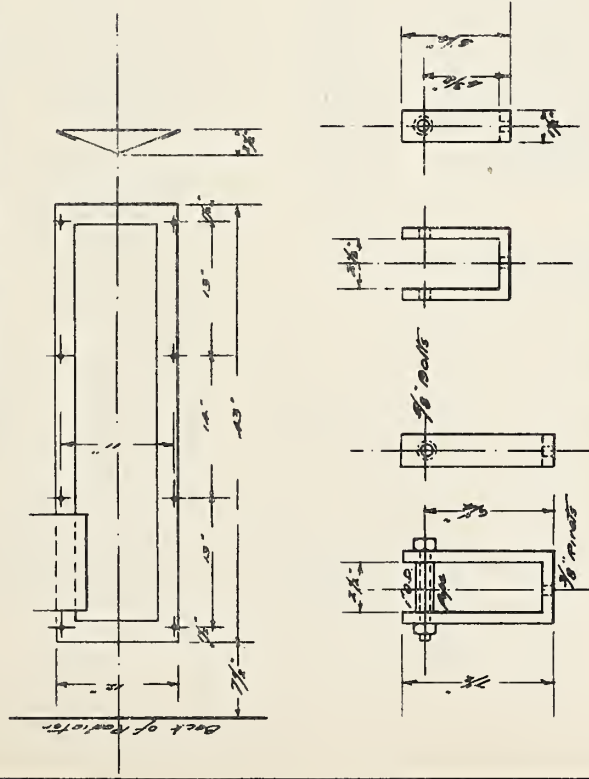
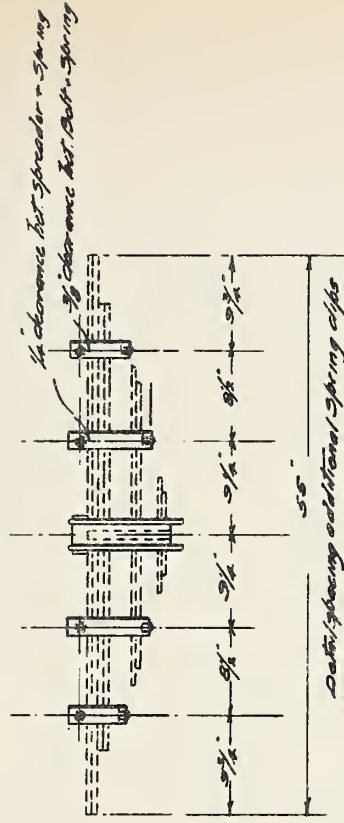
FRONT SPRING CLIPS FOR CLETRAC "55"

The Cletrac 40-55 is equipped with only two spring clips on the front springs. Trailmaker work is especially severe on the front springs, consequently the spring leaves themselves, shift.

The remedy is to install two additional spring clips. Details are shown below.

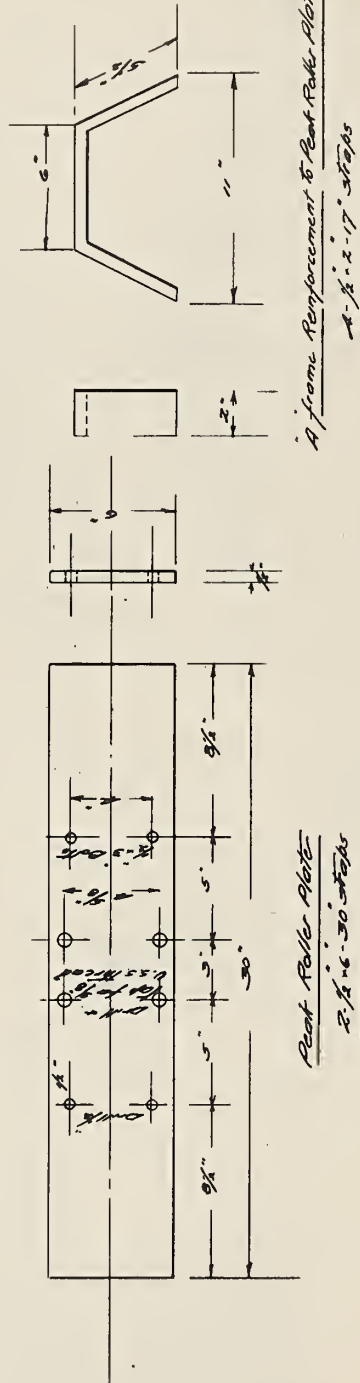
UPPER TRACK WHEEL BEARING ASSEMBLY FOR CLETRAC "55"

The Cletrac "40" and "55" have three small plain type upper track carriers that have no flanges to guide the track. In almost every case of major overhaul the rollers and bearings are found to be considerably worn.

As all models of the Cletrac have flanged upper track bearings, it was decided to replace the three present rollers with a single roller assembly which is interchangeable with the lower track wheel assembly. This is accomplished by mounting it on a plate 1 1/2" x 6" x 30" with the standard track frame studs, and which is in turn bolted to the top of the side frame housing. The reconditioned lower bearing and shaft is used, but as the load upon it is not as great as it would be in its original location, a slightly worn flanged wheel may be used, and has been found to be fully as serviceable as a new wheel. The cost is the same for the bearing and shaft assembly as for the lower wheel, but the wheels are salvaged from used parts.

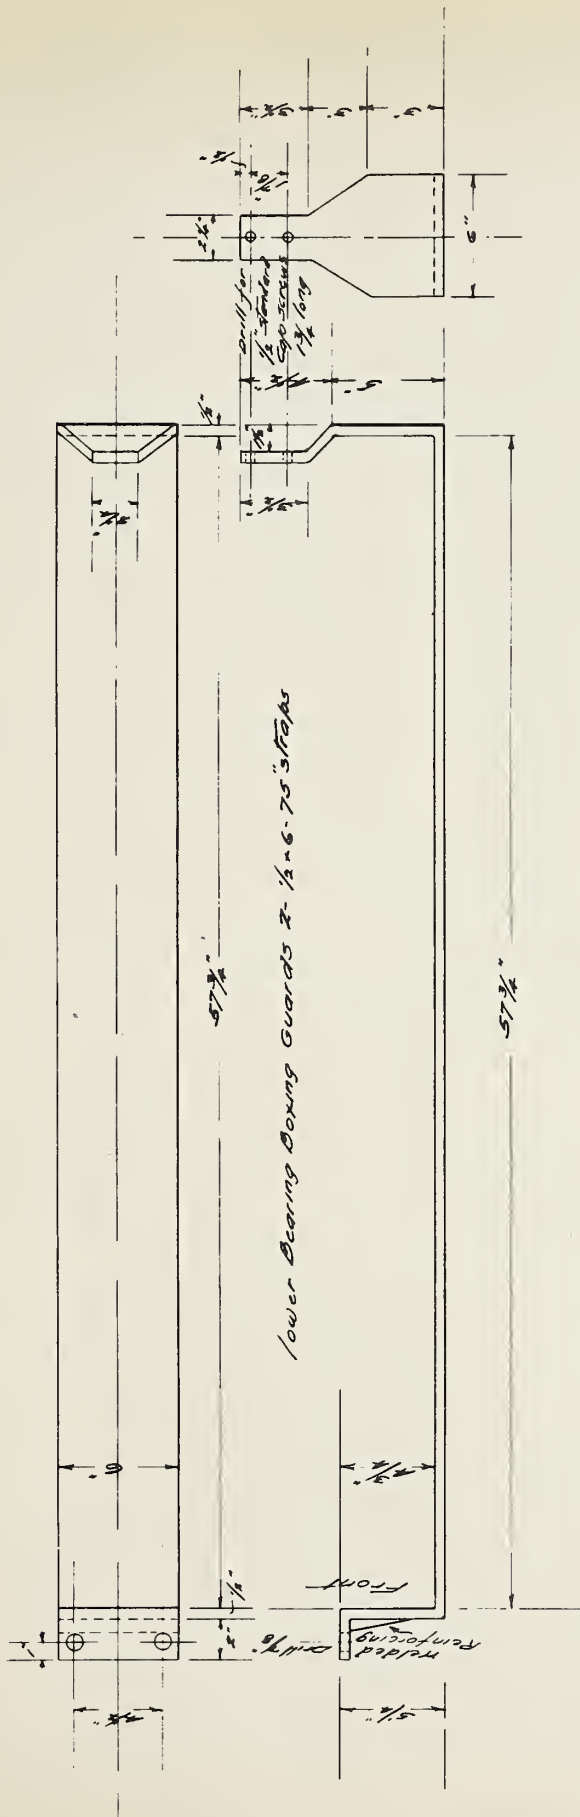
LOWER WHEEL BEARING GUARD FOR CLETRAC #55"

The regular lower wheel bearing guard as furnished by the Cleveland Tractor Company is bored to accommodate the socket wrench for tightening the lower wheel bearing nuts, and the cost is \$16.80. It is quite apparent that when the tractor is working in broken rock, a great deal of wear occurs both on the track and the bearing guard itself because of the fact that rock particles which are carried around the track will catch in these holes. Since no holes are provided for the tightening of each individual nut, it is of course necessary to remove the guard for periodical inspection and tightening; however it is felt that the labor involved is justified.

In an attempt to eliminate some of these difficulties, a plain type $1\frac{1}{2}$ " x 6" bearing guard is furnished. Details are shown above.

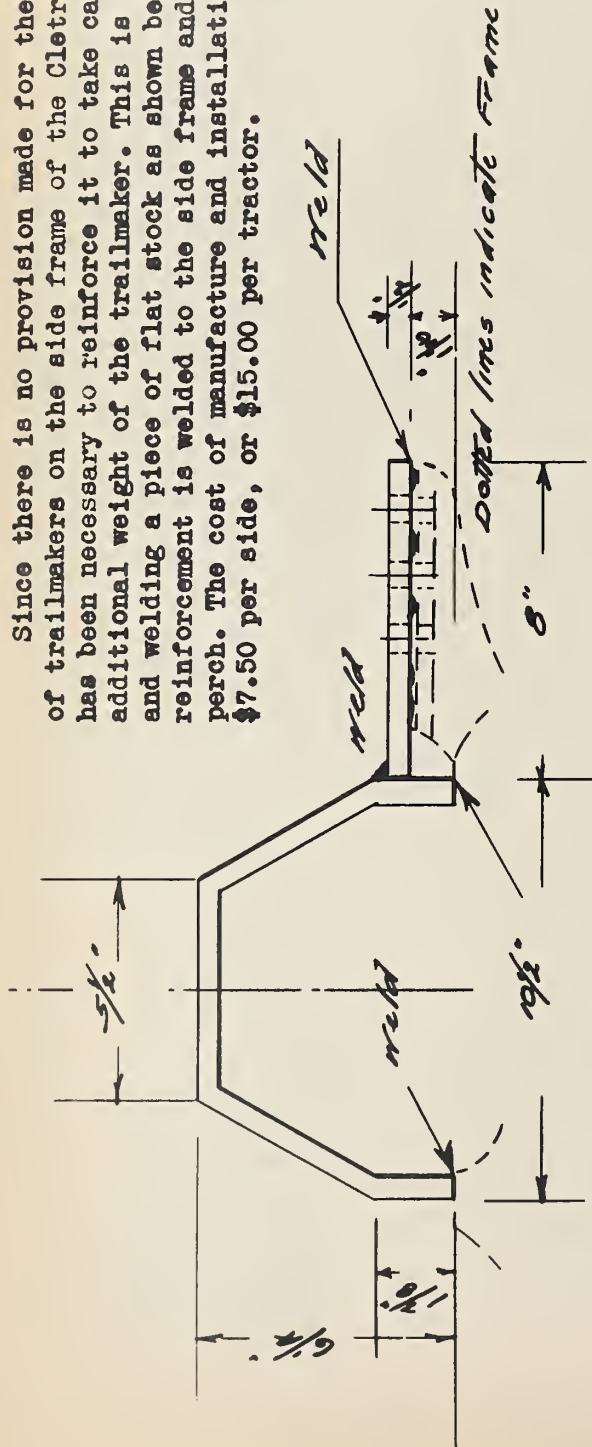
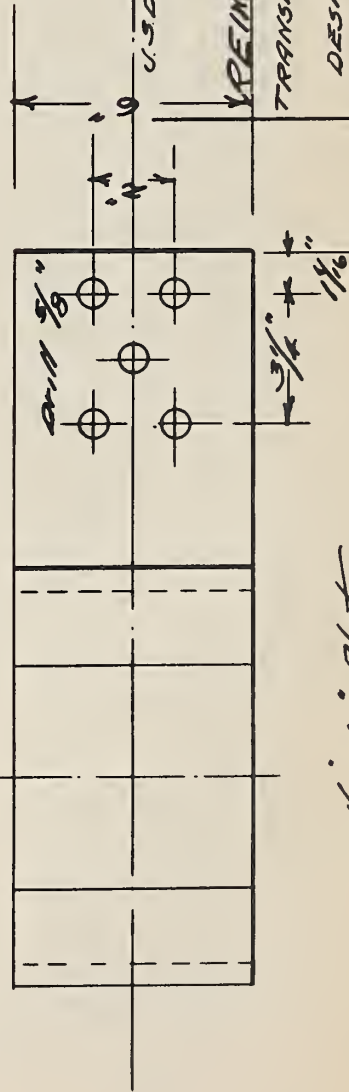
Reinforcement Side Frame to Spring Perch.

Since there is no provision made for the installation of trailmakers on the side frame of the Cletrac "55", it has been necessary to reinforce it to take care of the additional weight of the trailmaker. This is done by forming and welding a piece of flat stock as shown below. This reinforcement is welded to the side frame and to the spring perch. The cost of manufacture and installation is about \$7.50 per side, or \$15.00 per tractor.
